Manhole Inspection Summary

Manhole # S35YY1017MH

Insp Date: **5/1/07 10:39 AM**

Location Address: **226 SAINT DUNSTANS RD**

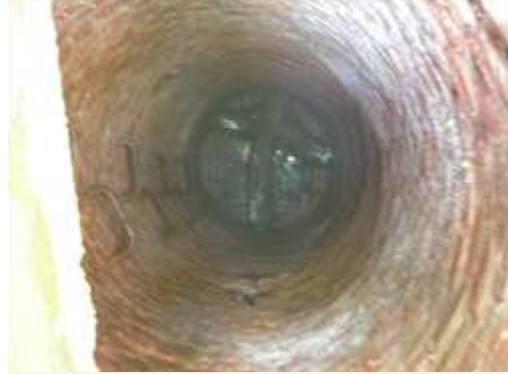
Top View

Corroded steps. Bench debris.

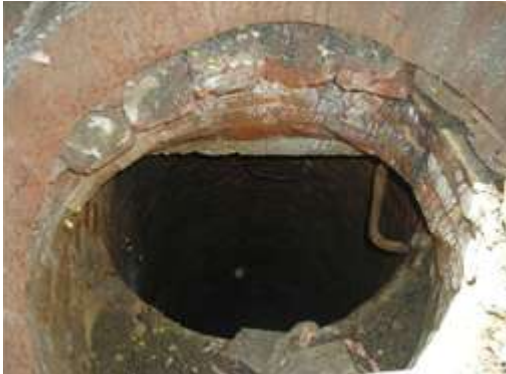
Defect

Frame leaks. Frame offset. Adjustment deterioration, loose brick and infiltration. Corbel and Barrel infiltration - other side.

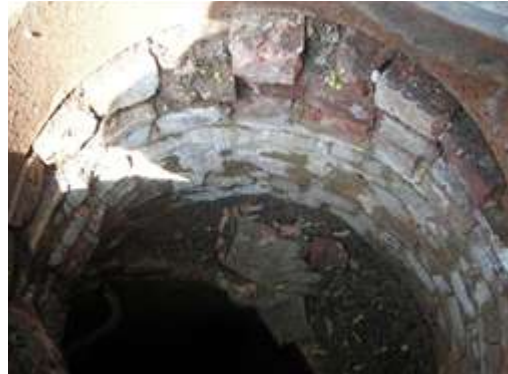
Defect

Frame leaks. Frame offset. Adjustment deterioration, loose brick and infiltration. Corbel and Barrel infiltration.

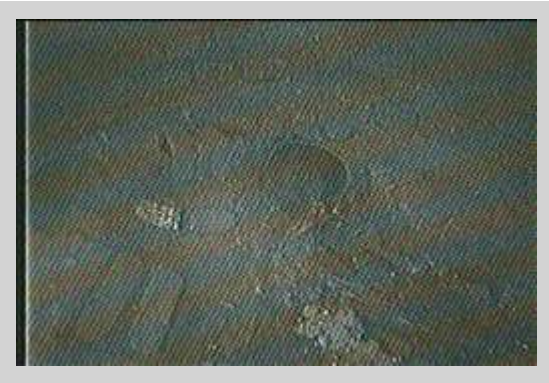
8 in. Circular Gravity Sewer Pipe Out @ 12 O'Clock

Infiltration: **Evidence** Pipe Seal Cond: **Cracked**

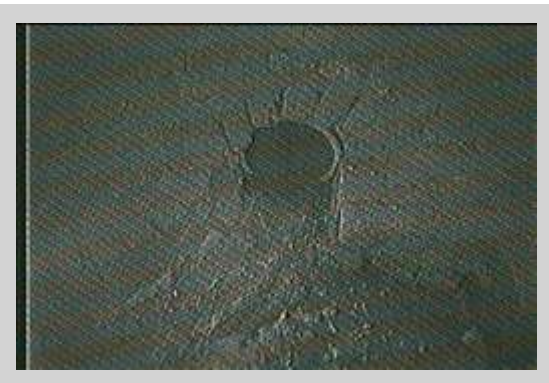
8 in. Circular Gravity Sewer Pipe In @ 3 O'Clock

Infiltration: **None** Pipe Seal Cond: **Broken**

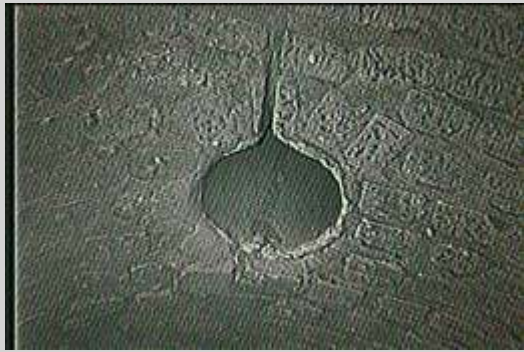
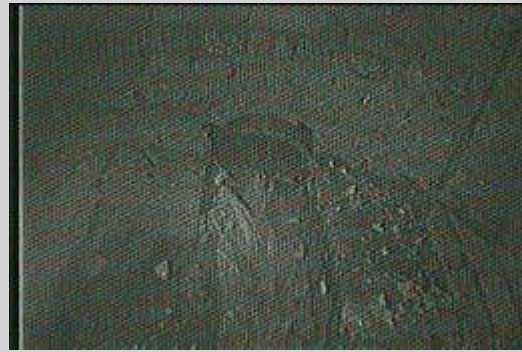
Pipe In @ 6 O'Clock

Infiltration: **None** Pipe Seal Cond: **Broken**

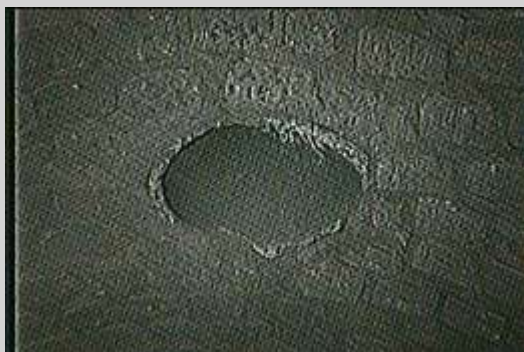
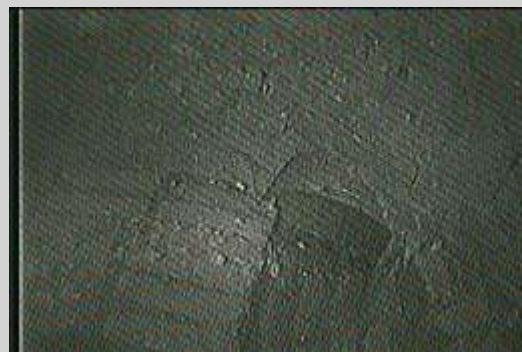
Pipe In @ 9 O'Clock

Barrel deterioration and infiltration.
